# **DEMONSTRATION AND VALIDATION OF TECHNOLOGIES TO MITIGATE CORROSION ON INFRASTRUCTURE COMPONENTS AT FORT BRAGG: INITIAL RESULTS**

Concurrent Technologies Corporation (CTC)

U.S. Army Corps of Engineers, Engineer Research and Development Center, Construction Engineering Research Laboratory  
(ERDC-CERL)

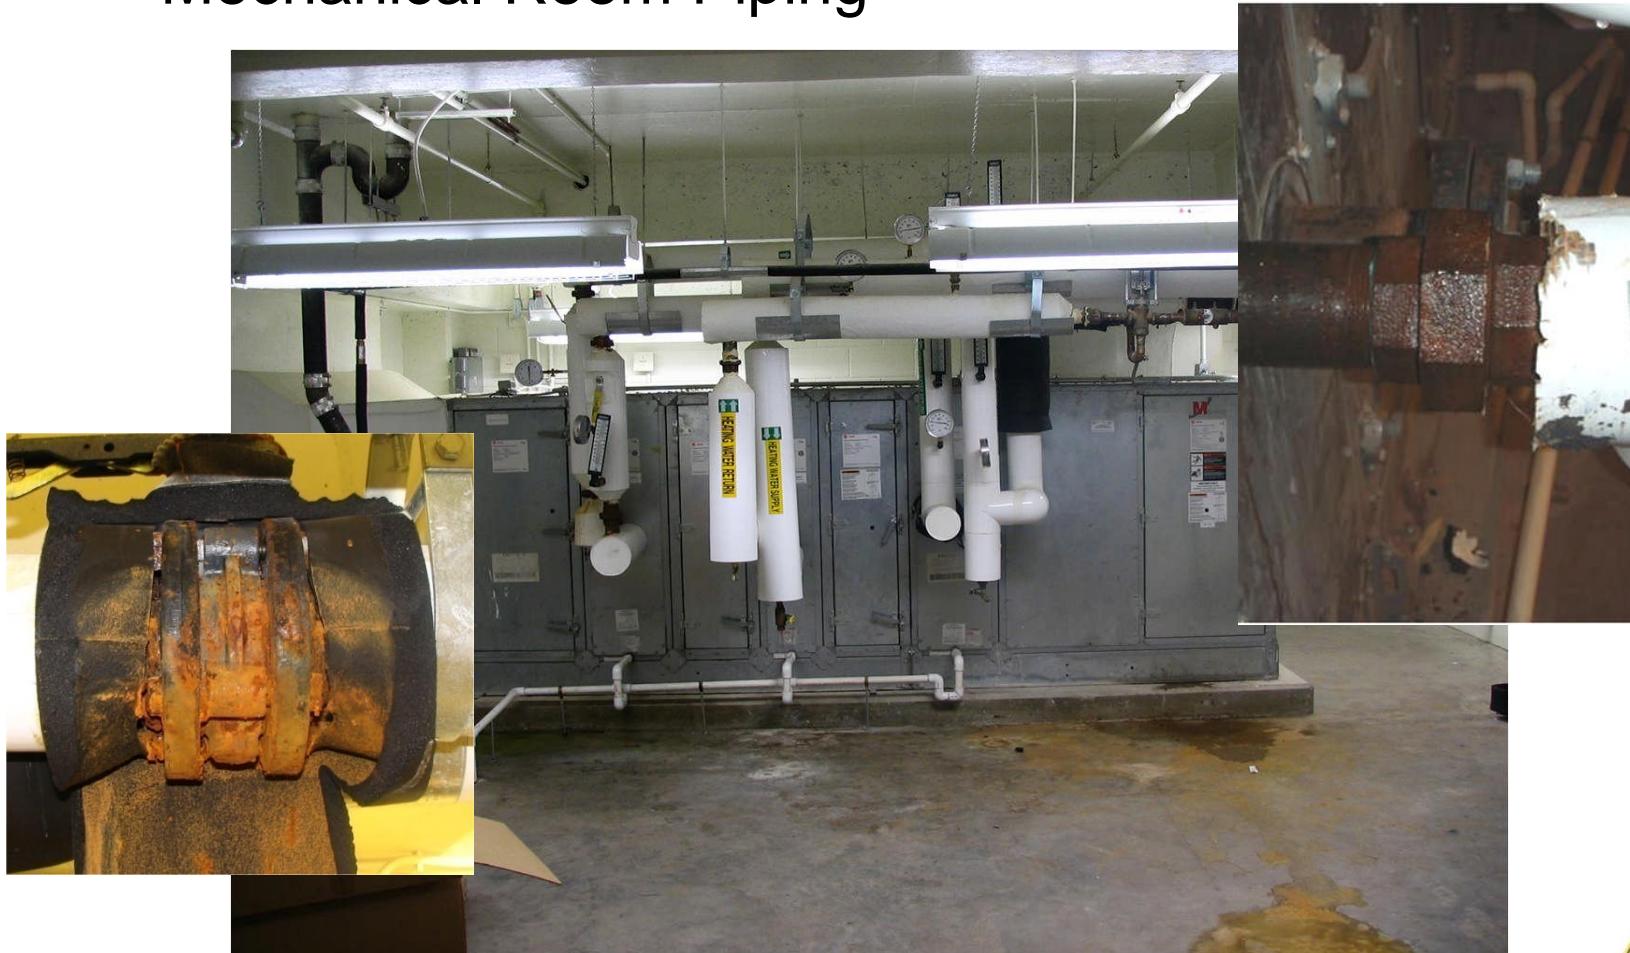
- Serious corrosion of infrastructure components evident at Fort Bragg, NC
- Two key issues
  - Mechanical Rooms
    - Example - newly constructed 16th Military Police Barracks
      - Accelerated corrosion of exposed union joints
      - Significant amount of condensate build-up on insulation covering supply lines
  - Cooling Tower Pumps
    - Relatively new (put on line in 1996) central cooling plant
    - Vertical cooling towers and pumps corroding
    - Total failure due to corrosion within two to four years of operation

Mechanical Room at Fort Bragg, with corroded piping union joints

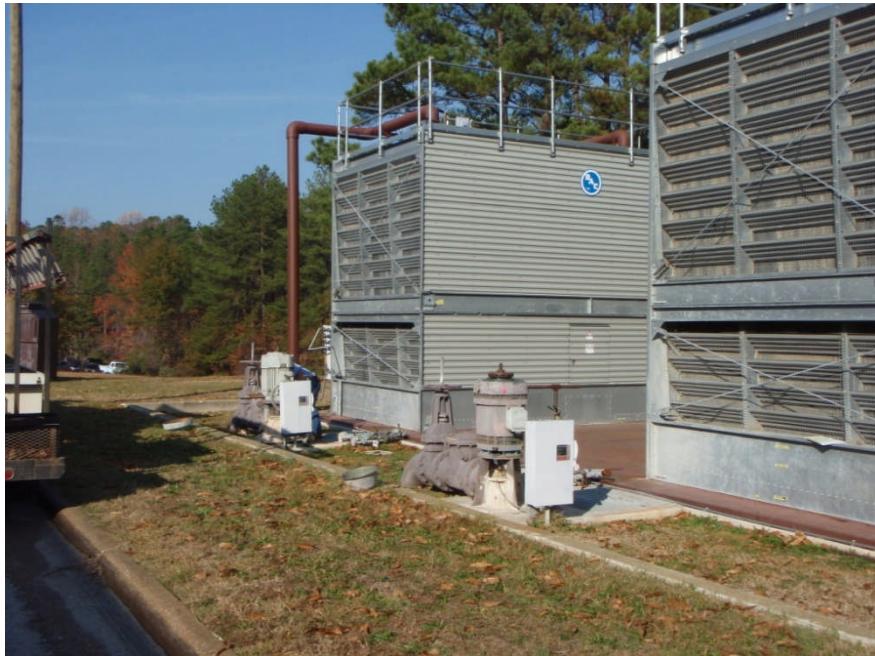
Cooling towers, Central Cooling Plant, Fort Bragg

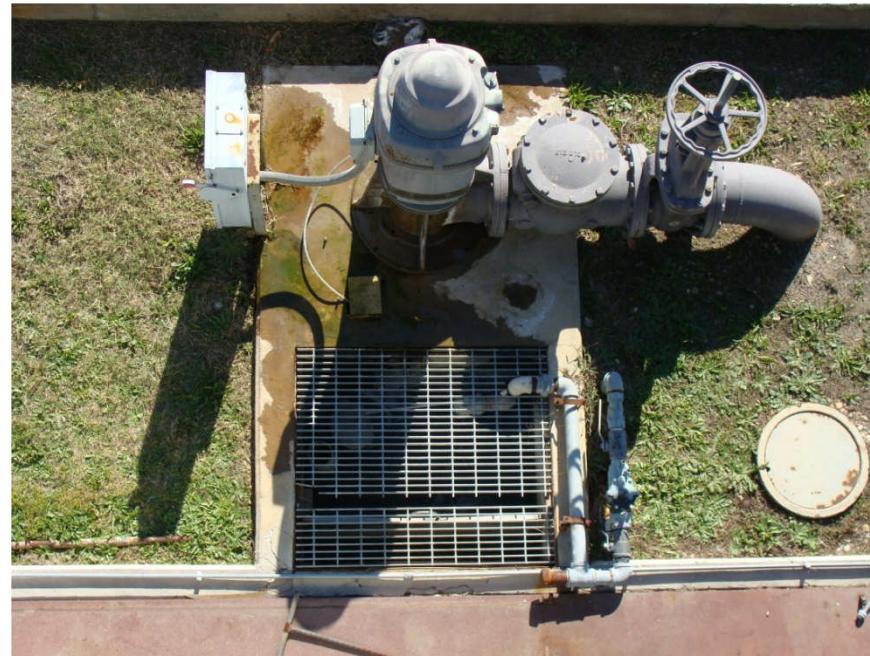
Overhead view of pump sump

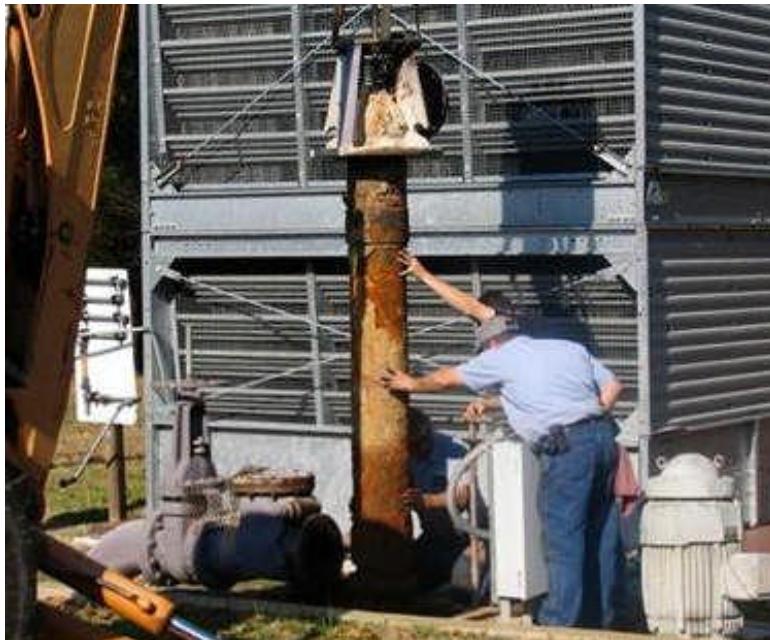
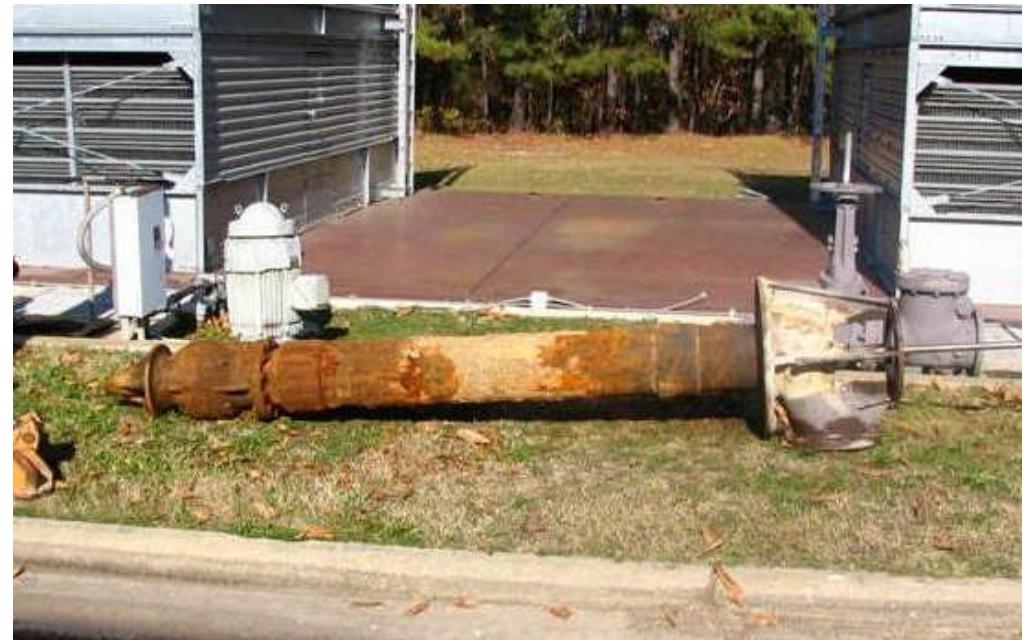
Removed pump, showing severe corrosion on shaft (near water surface)

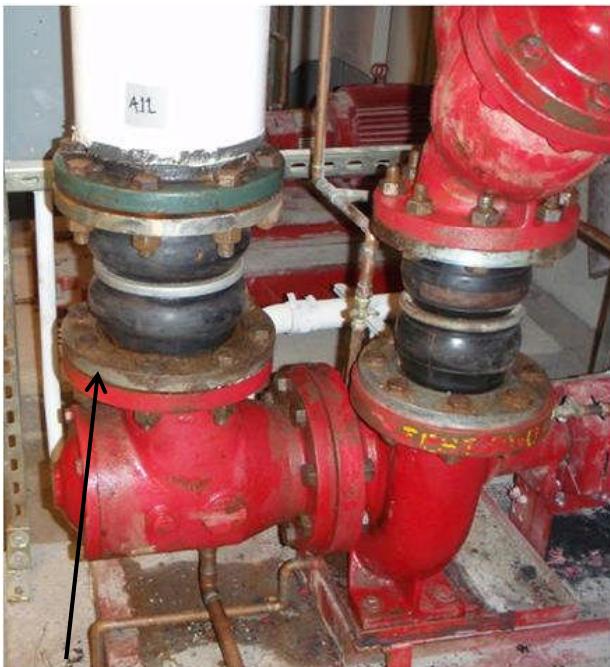
Pre-installation, chill water pump:  
rust evident even on stainless  
steel flanges

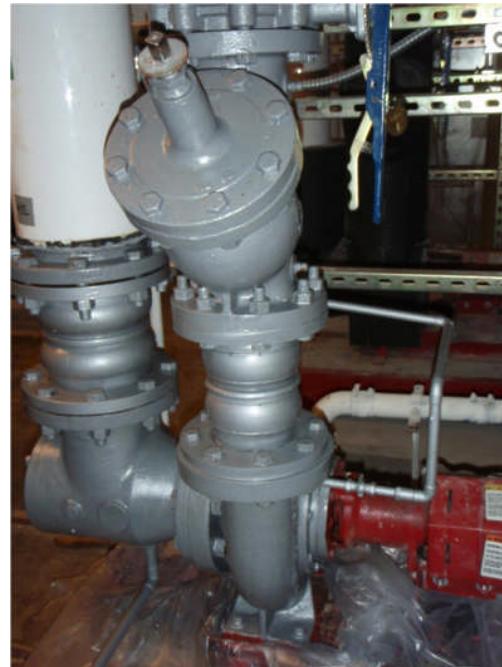
Primer: aluminum-loaded  
polyurethane

- Mechanical Room Piping and Joints
  - Existing rust from exposed piping removed
  - Coating systems applied

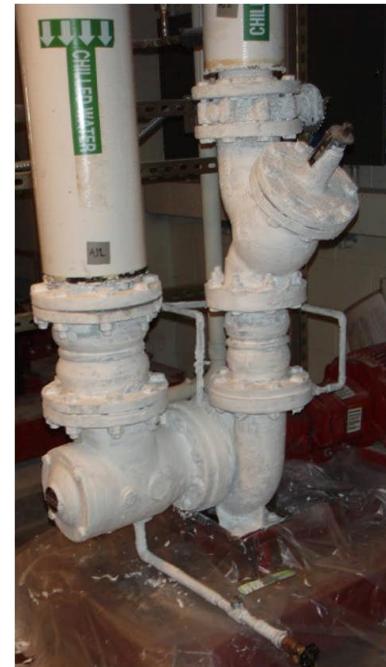
Ceramic topcoat

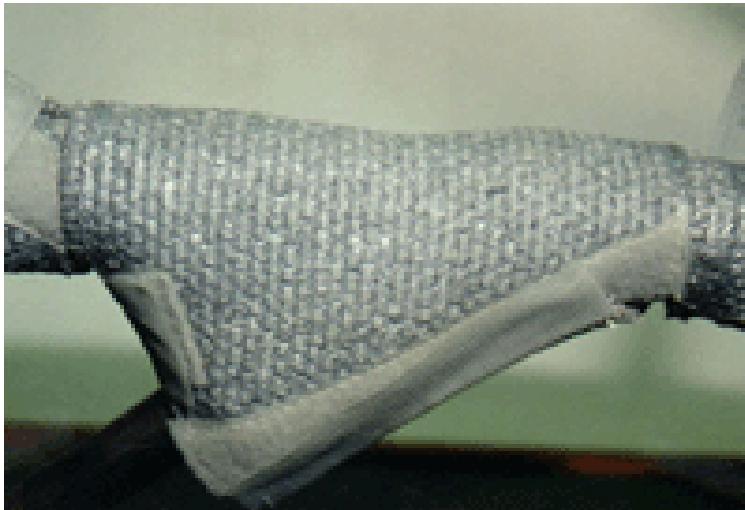
Removable insulation

- Mechanical Rooms (cont.)
  - In general, the removable insulation was not effective
    - Difficult to apply, loose fitting
    - Accumulated water (condensation) that dripped out of the ends

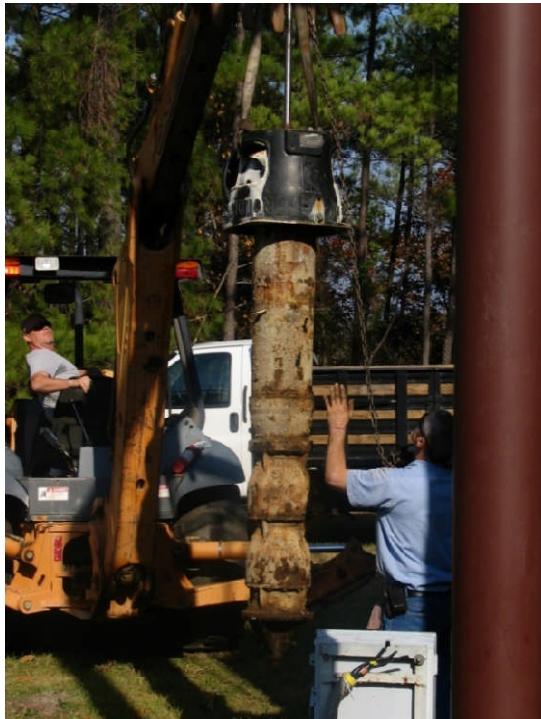
Pump being removed

- Cooling Tower Pumps
  - Pumps removed
  - Sandblasted to remove corrosion

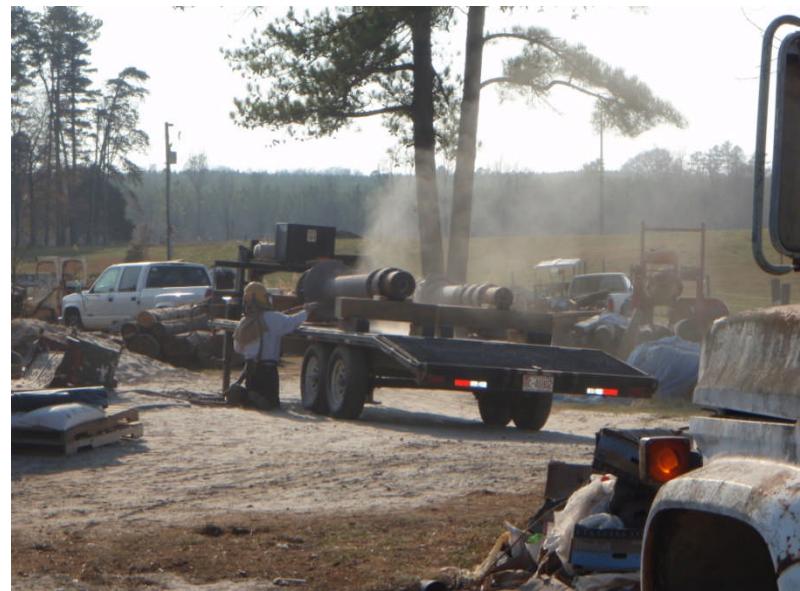
Sandblasting

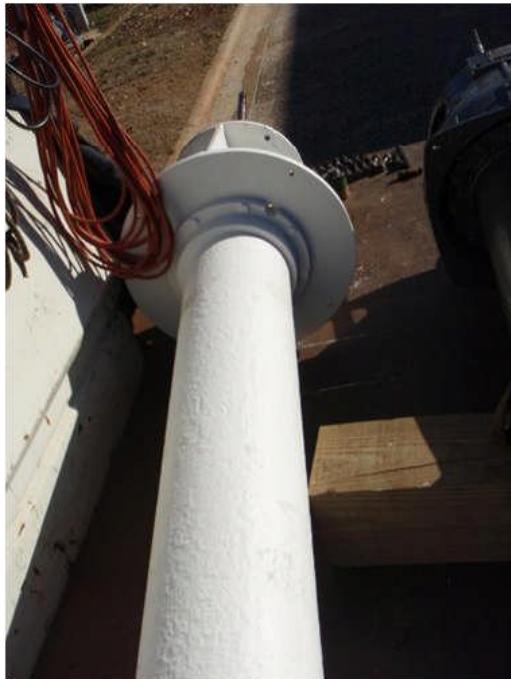
Paint System No. 21-A-Z

- Cooling Tower Pumps
  - Coating systems applied
  - Pumps reinstalled

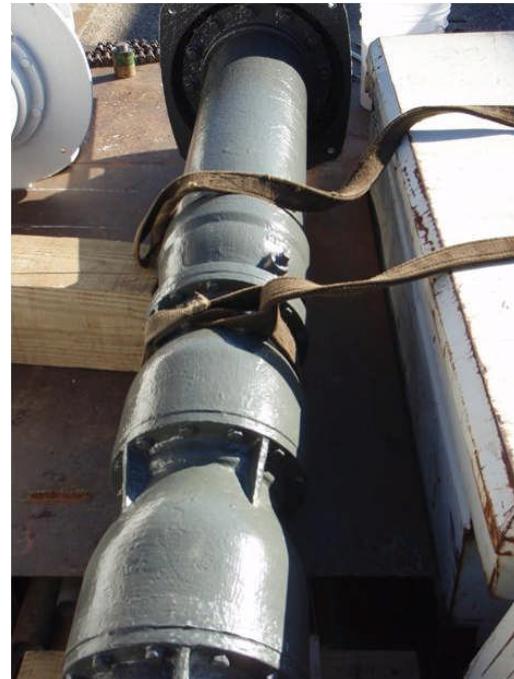
Epoxy System

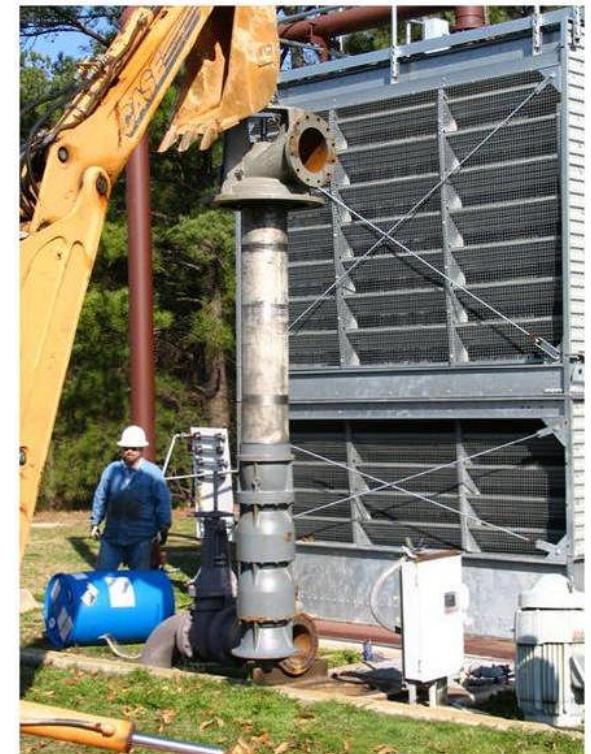
316 Stainless Steel

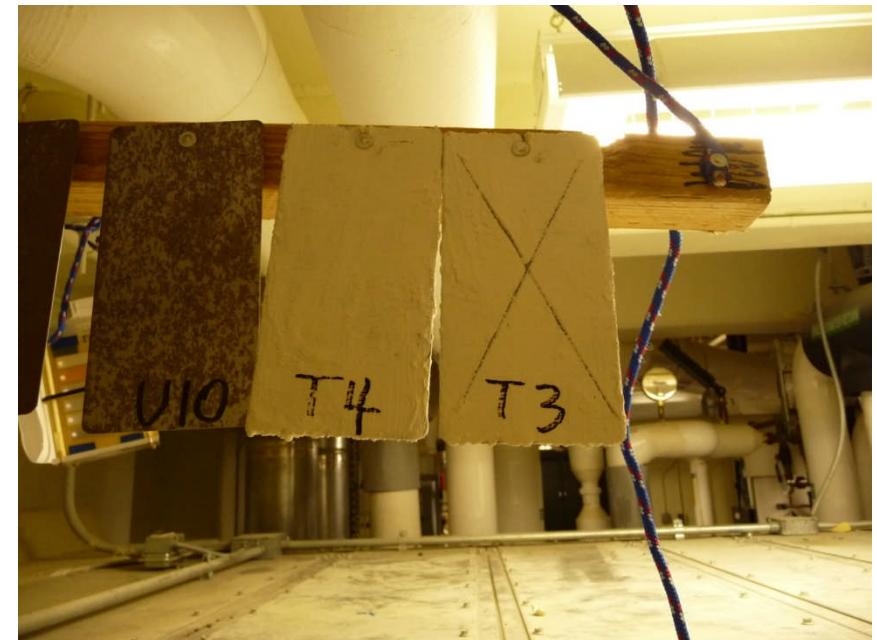
- Mechanical Rooms
  - Coated test panels in all mechanical rooms pristine after twelve months of exposure

Coated Test Panels, Mechanical Room A, Twelve Months of Exposure

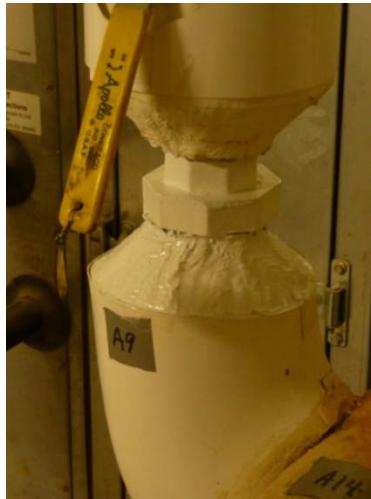
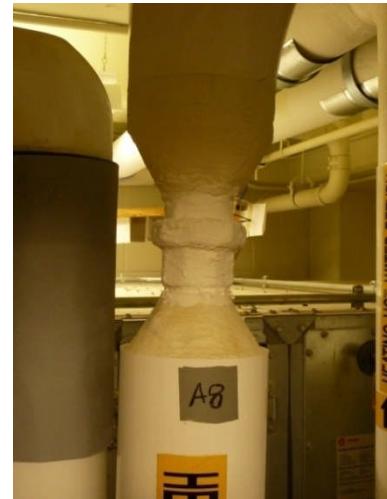
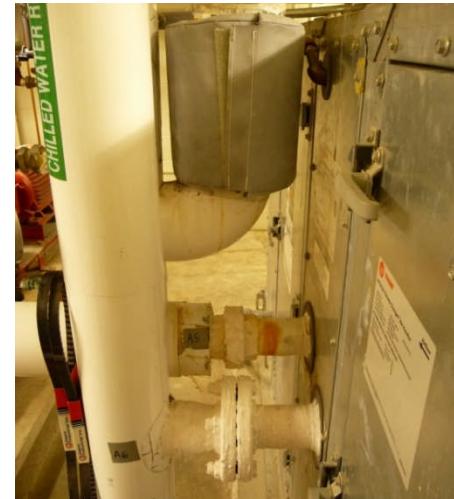
- Mechanical Rooms (cont.)
  - Coated fittings generally performed well
    - Some corrosion after twelve months of exposure, but only in certain instances
    - Both coatings performed better on hot water lines than on cold water lines, as expected
      - Condensation on cold water lines is a contributor
    - Performance not consistent on all fittings

Coated Union Joints, Mechanical Room A, Twelve Months of Exposure

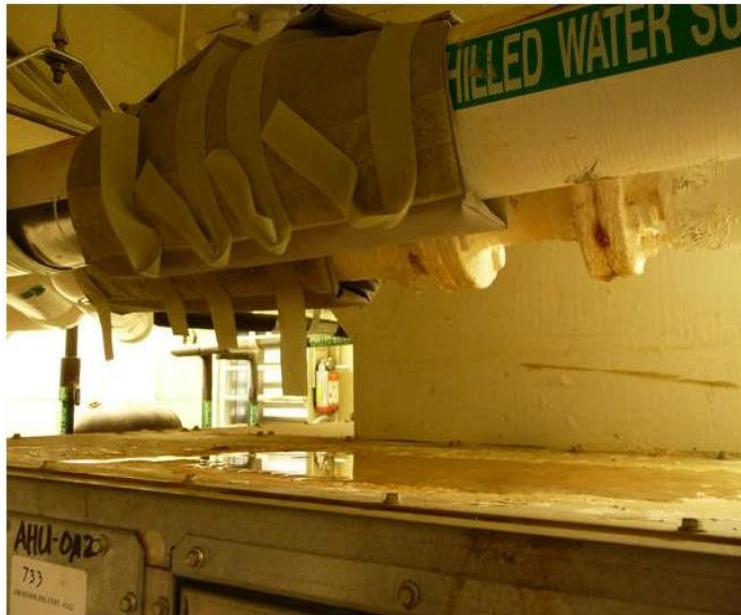
Union Joint with Removable Insulation,  
Mechanical Room A, Nine Months of Exposure

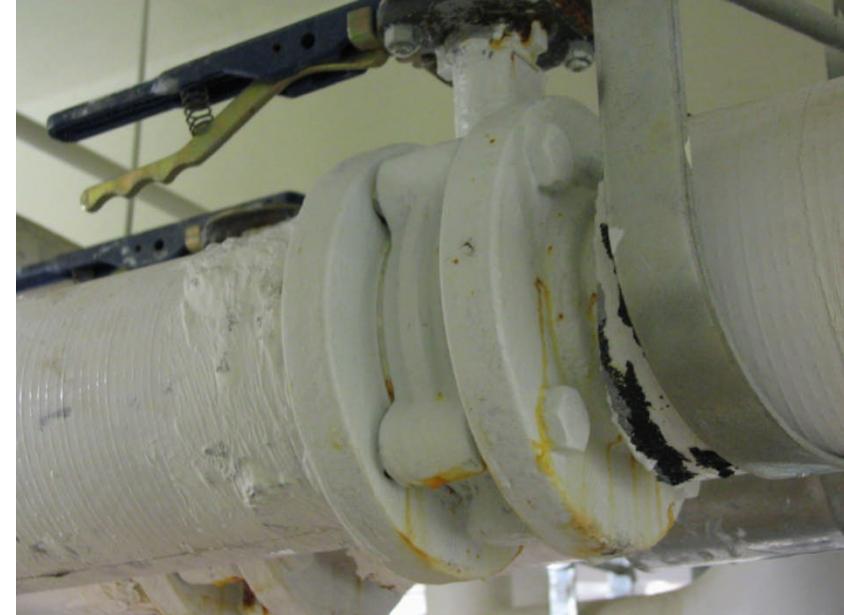
Union Joint with Insulation Removed,  
Mechanical Room A,  
Twelve Months of Exposure

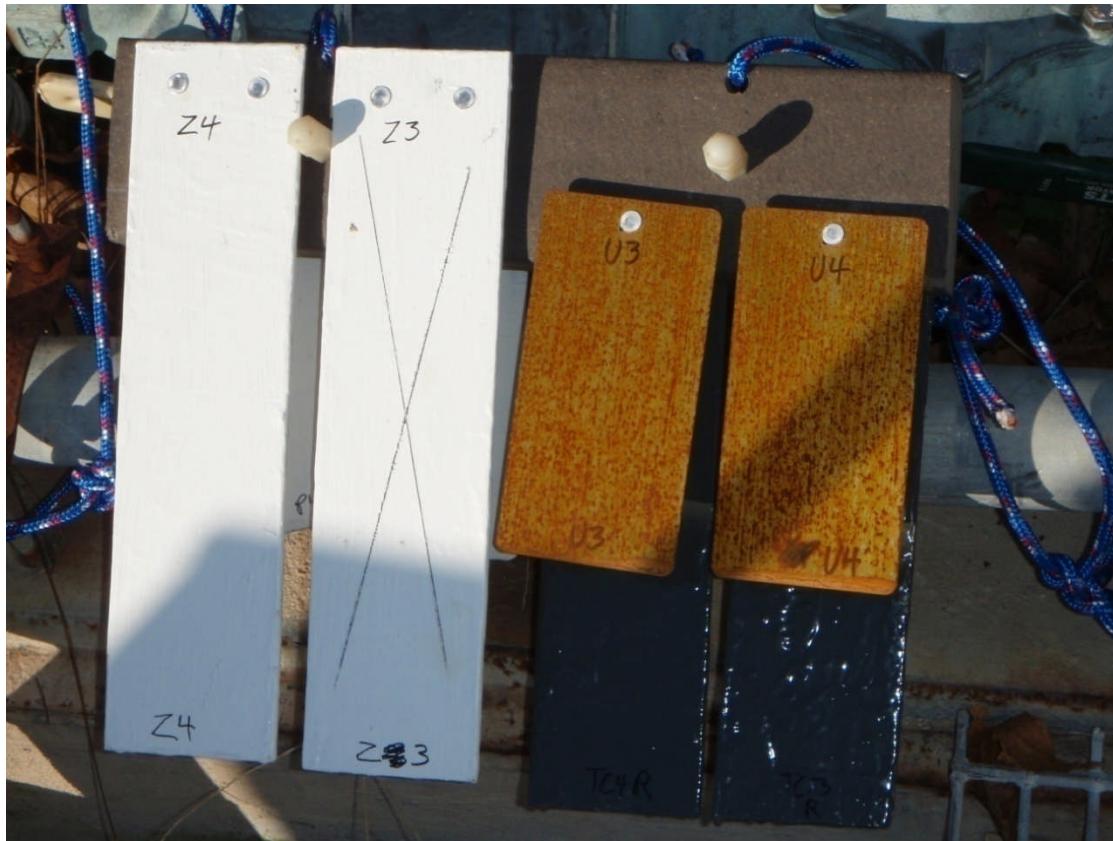
- Cooling Tower Pumps
  - Corrosion observed on uncoated panels in sumps in Feb 2009 (one-month exposure)

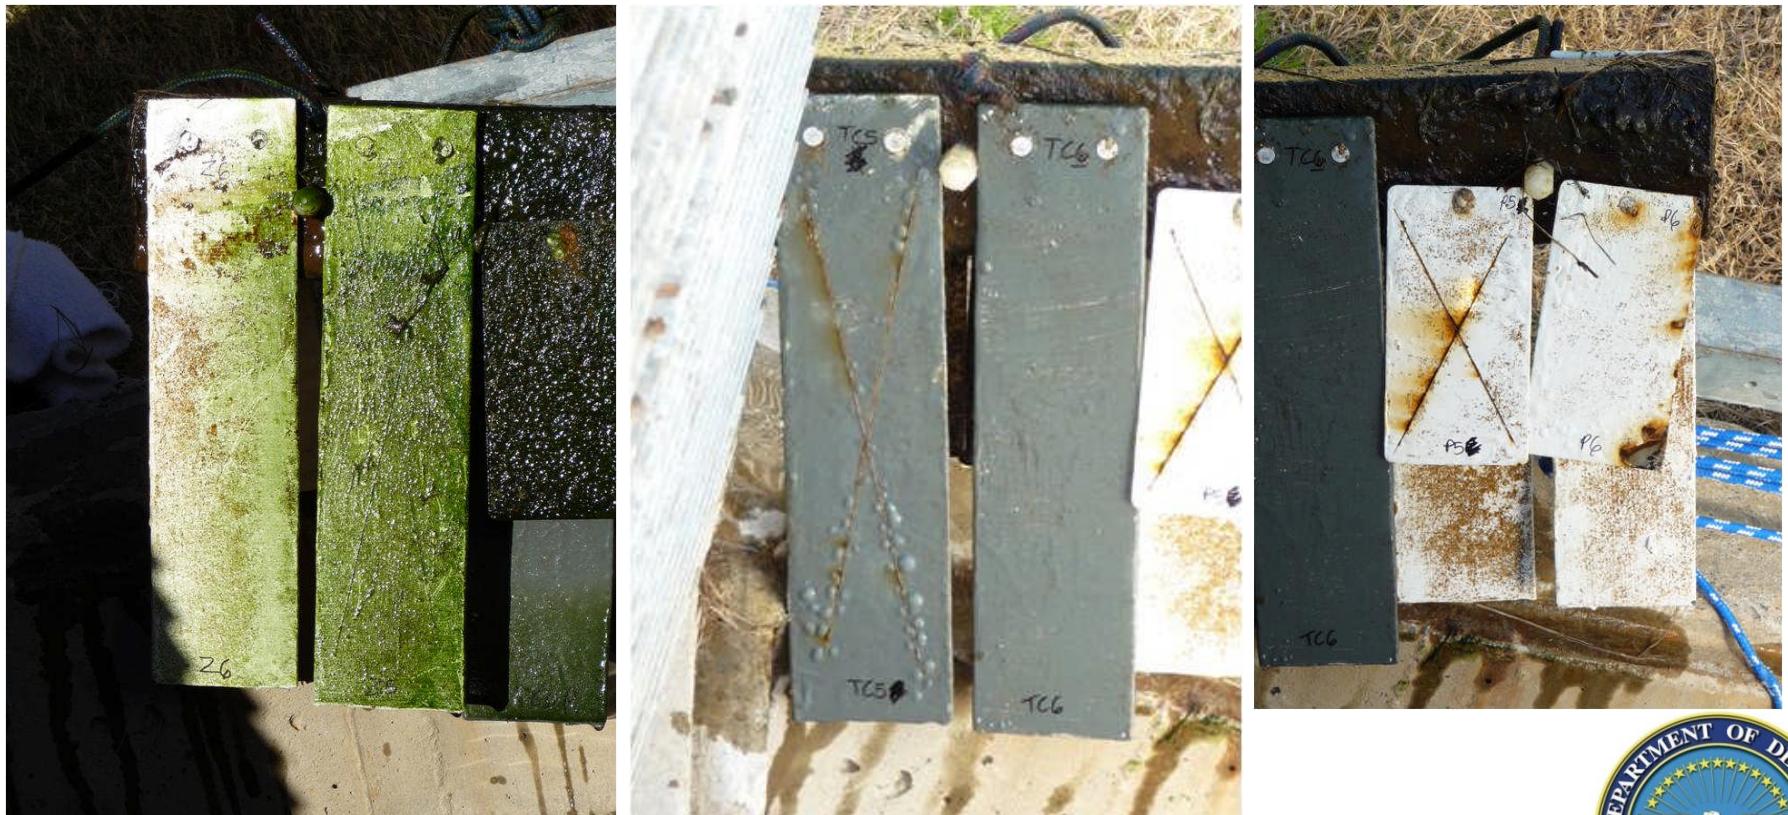
- Cooling Tower Pumps (cont.)
  - After twelve months of exposure, Paint System No. 21-A-Z outperformed commercial epoxy system
